Streamside Stewards Program

Final Report
2020-21

SHADE ANALYSIS METHODOLOGY

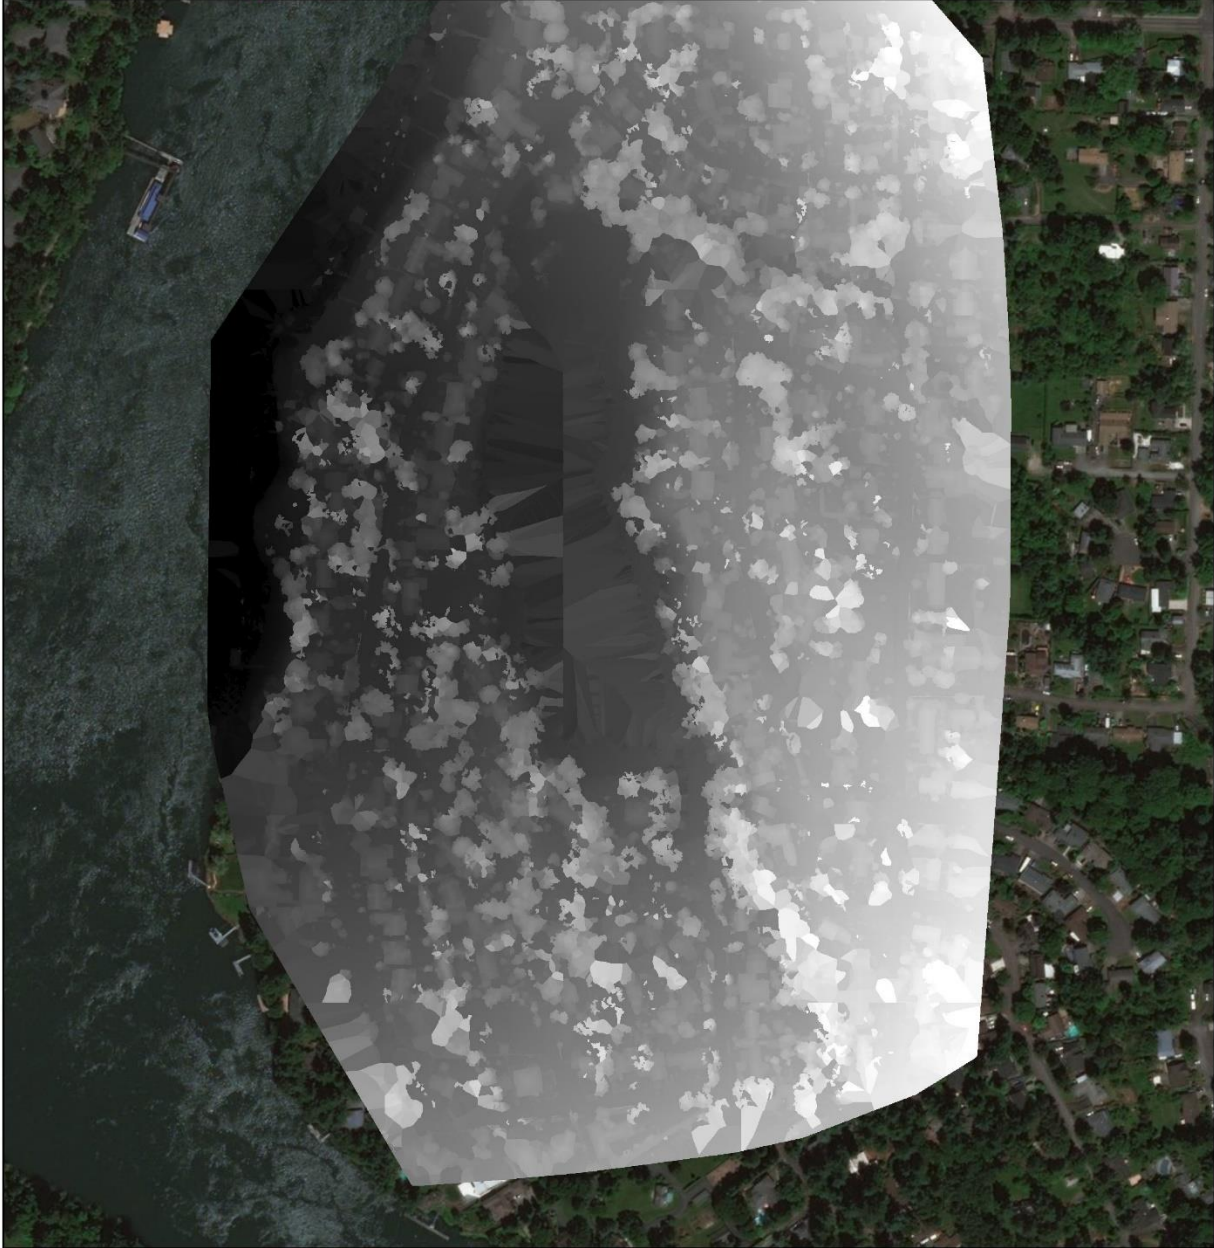
Digital Surface Model

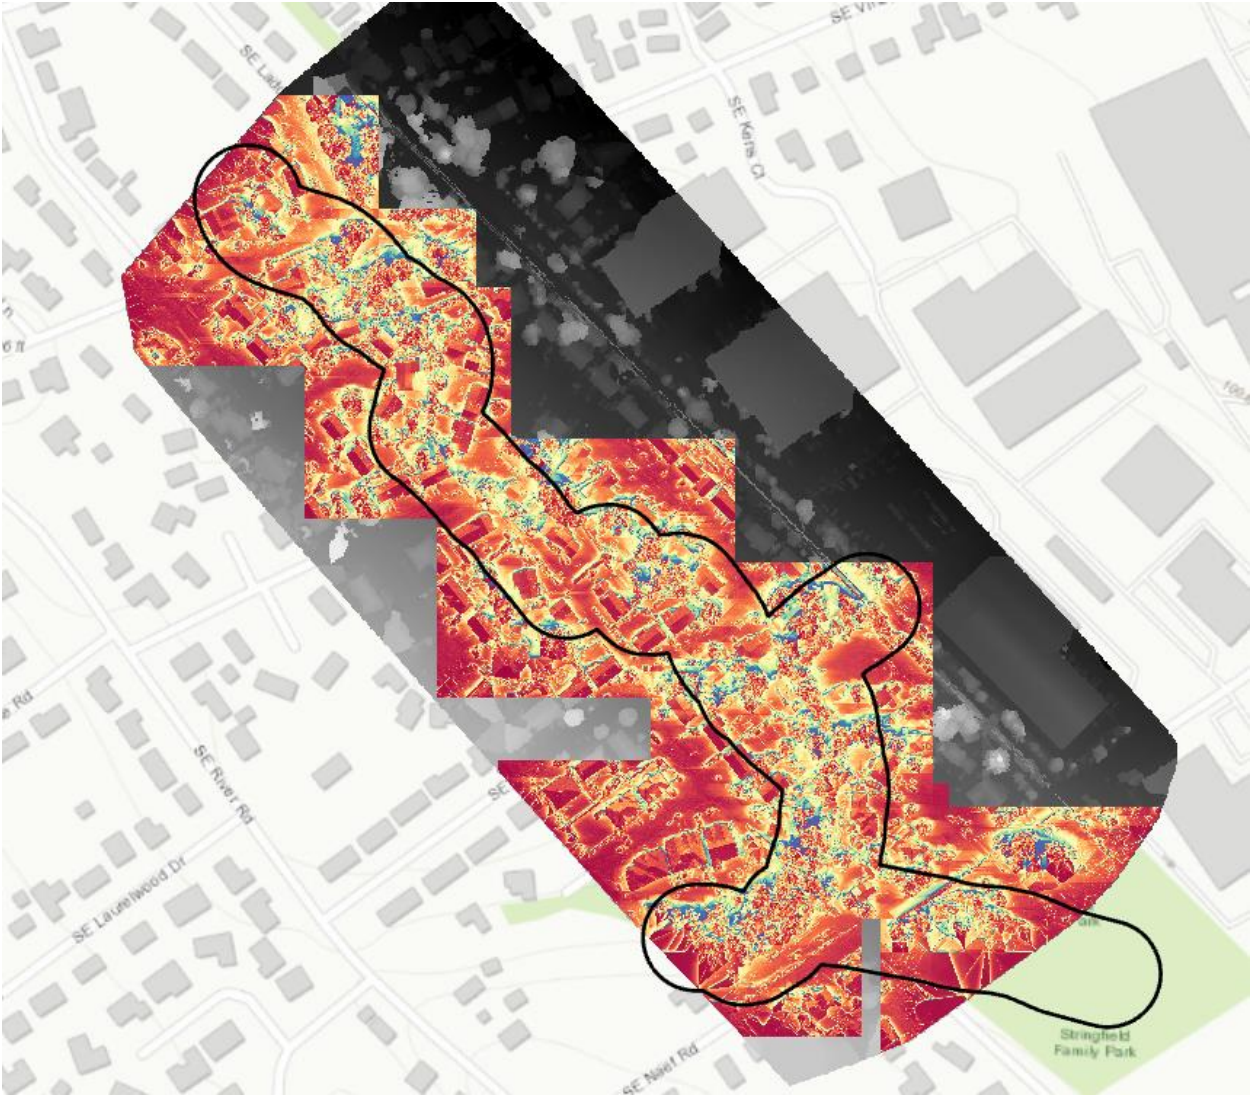
Example of Boardman Creek 2 Area Solar Radiation rendering (8-9 taxlot chunks; between 3 to 11 hours each)

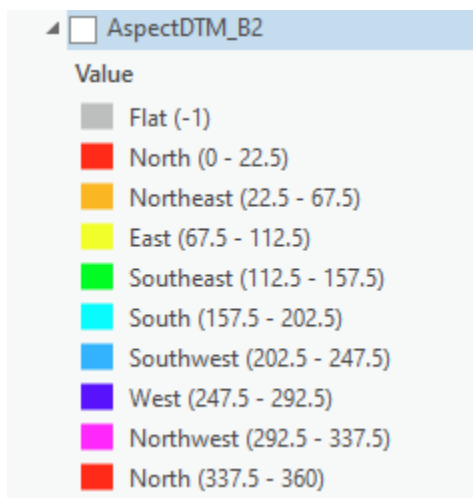
The output file should be represented by cardinal directions and degrees

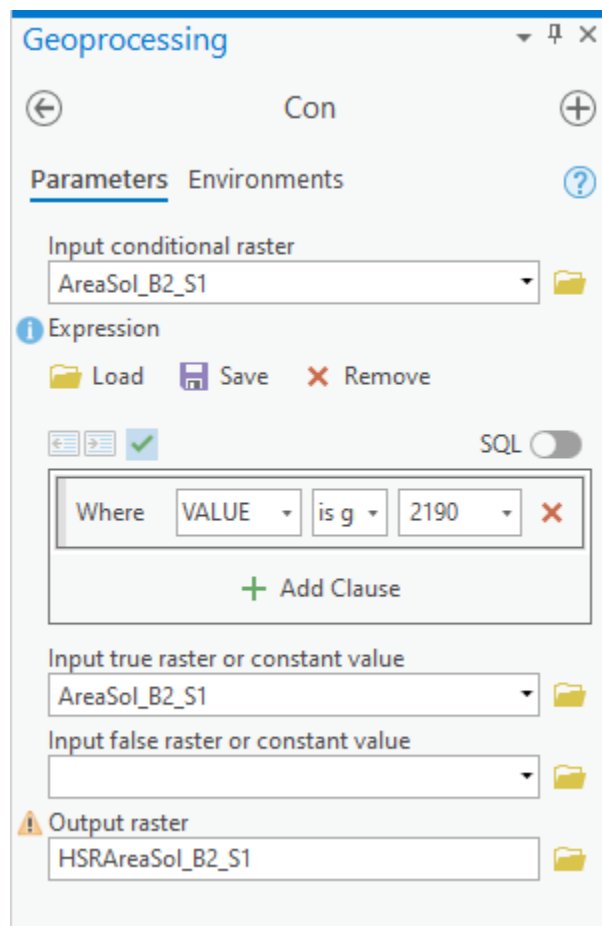
Make the **Input Conditional Raster** and **True Raster** both match as the desired solar raster.

Set the **Clause** where **VALUE** is greater than or equal to 2190.

Set location and name then click **Run**.

Conditions for finding areas to prioritize shade restoration projects are determined using the aspect and solar radiation rasters of a study area. Areas highlighted are greater than or equal to 2190 whm2 (solar) and between 112.5° - 292.5° (aspect). Further analysis can be conducted to clip out the vegetation layer from the con raster and then intersected with taxlots to see what areas should be prioritized.

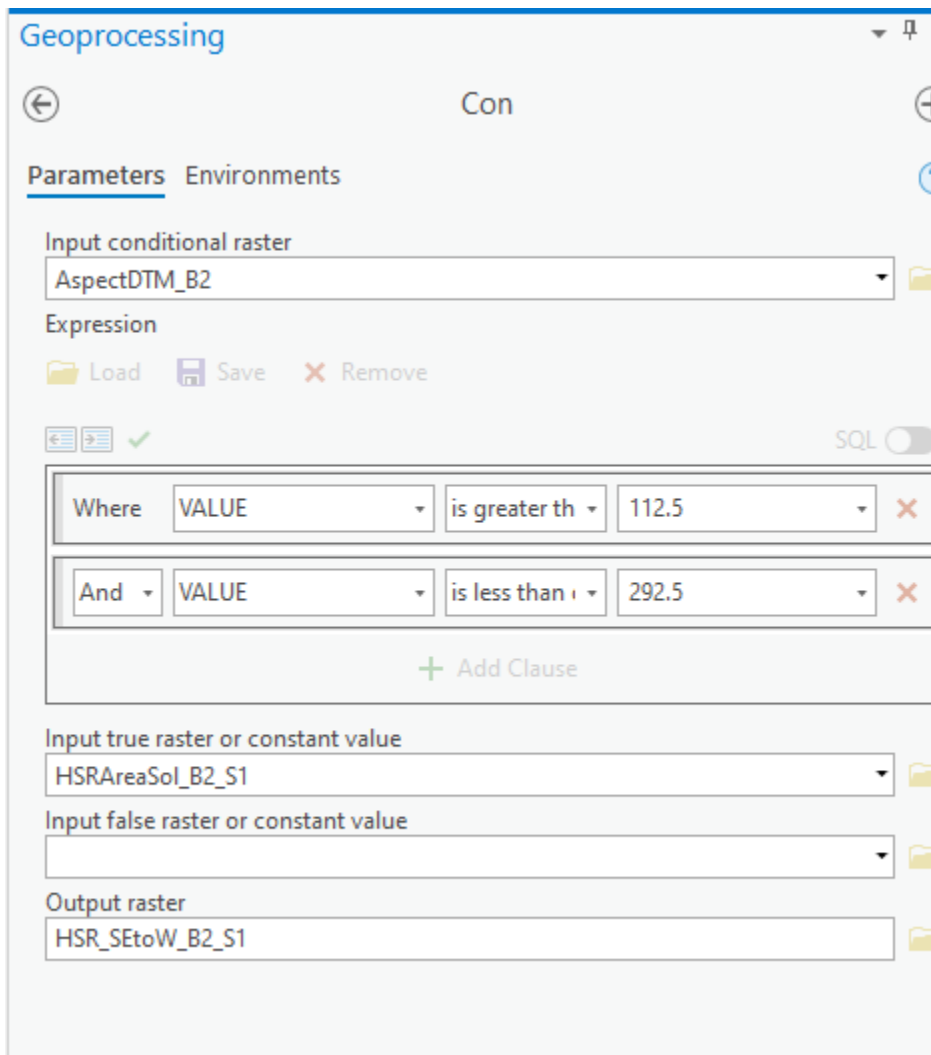
- Return to the **Con** tool to set the aspect. These new Parameters include:
Input Conditional: Aspect layer (AspectDTM_B2)
Input True: Previously created Con raster (HSRAreaSol_B2_S1)
Clause: Where **VALUE** is greater than or equal to **112.5**
(+ Add Clause) **AND** where **VALUE** is less than or equal to **292.5**
Output: appropriate name and file location (HSR_SEtoW_B2_S1)
