## **Grant Application**

## USDA Forest Service Crooked River National Grassland

## Eastside Wildlife Water and Habitat Restoration Project

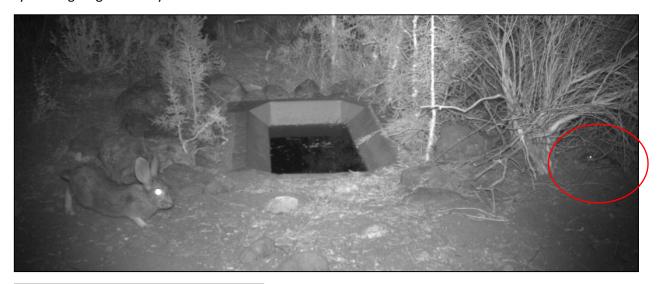
Figure 7 below shows a rabbit coming for a drink, with a rattlesnake lying in wait, with only his reflected eyeshine giving him away.

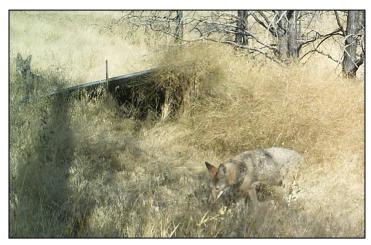
**Figure 9:** Two coyotes stop by a guzzler during a warm August day for a drink. This pair of coyotes visited this guzzler nearly every day during the trapping period. Many guzzlers received visits from coyotes as well as other mesocarnivores like bobcats.

Figures 8 and 9 above show that it appears that some species struggle to share the water source, while others seem to have no issue coexisting.

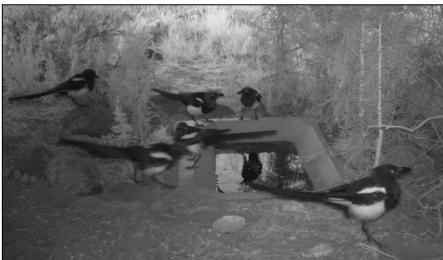
**Figure 10:** Many different species of resident and migratory birds utilized the guzzlers during the day from the early hours in the morning to after dusk.

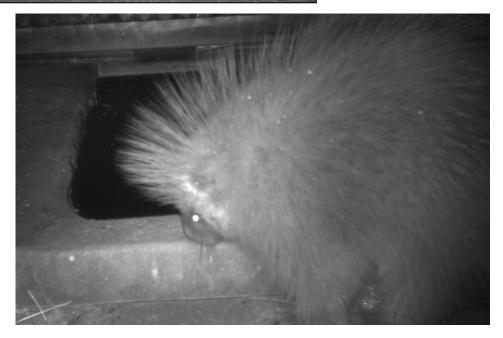
Figure 11: Less frequently observed animals such as porcupines, badgers, and other unique wildlife were also found to be using these water sources.
